EVALUATION OF SUB-GRADE INFLUENCE IN RIGID PAVEMENT: A CASE STUDY IN THE SECTION OF THE RING ROAD FROM KALITY TO HANA MARIAM

**A Thesis Submitted to
The School of Graduate Studies of Addis Ababa Science and Technology
University in Partial Fulfillment of the Requirement for the Degree of
Master of Science in Geotechnical Engineering.**

**ADDIS ABABA SCIENCE AND TECHNOLOGY UNIVERSITY
SCHOOL OF CIVIL AND ENVIRONMENTAL ENGINEERING**

January 2019

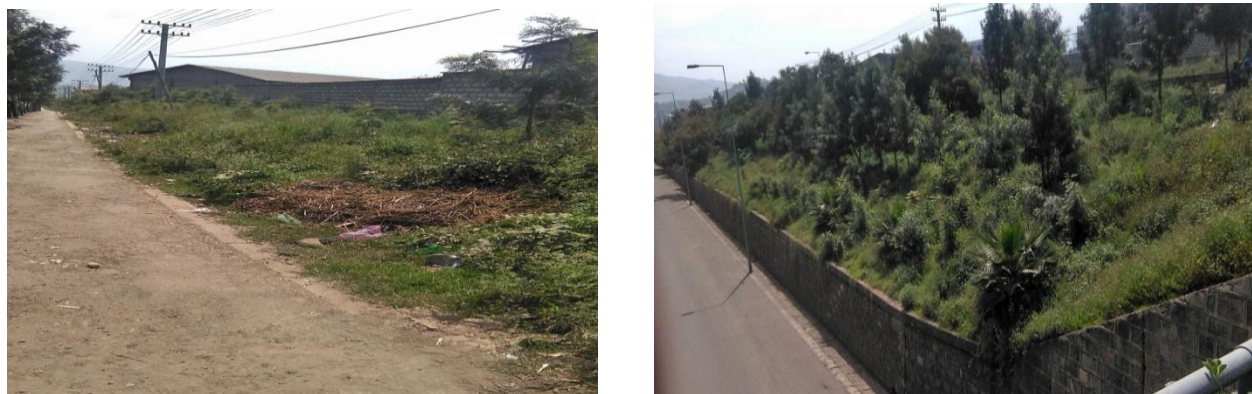
Figure 3.5: Land cover of the research area

During the field observations and investigations, it has been shown that the side road from km 0+000 to km 0+275 is covered with scattered artificial and natural plants.

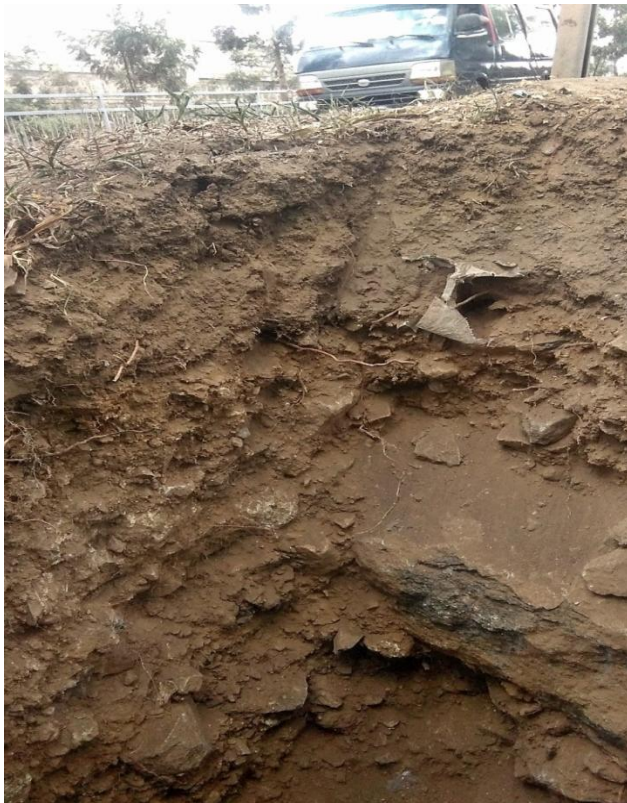
From the visual inspection of the site, the left side of the road is embankment covered by trees and grass and the right side of the road is border of Ethiopian Water Technology Institute. The predominant soil type observed for almost the whole side of the road covered by black cotton soil which is usually considered as unsuitable material for any structural purpose.

a) Fill material at 0+034 km RHS

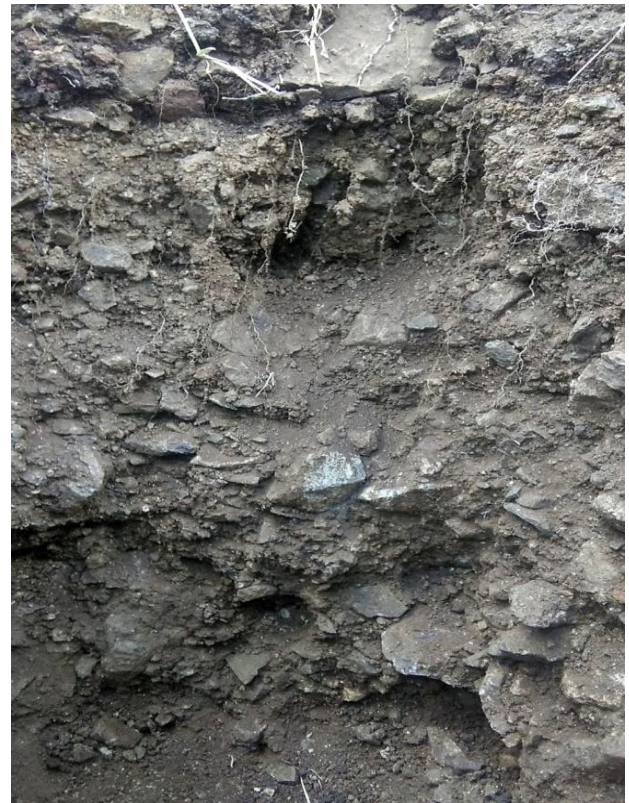
b) Fill material RHS at 0+175 km

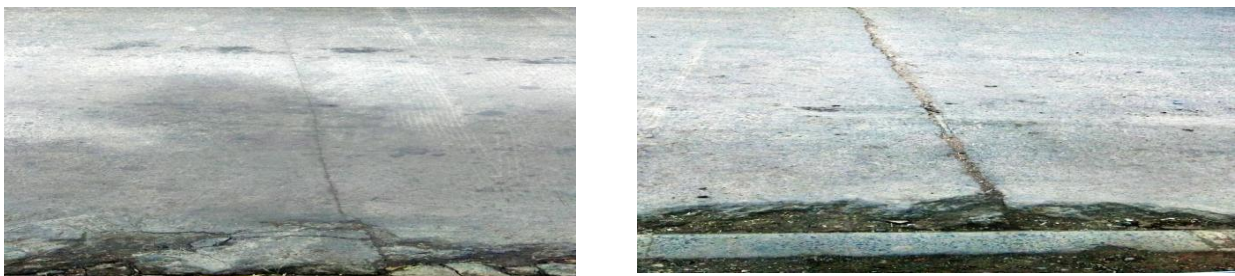
Figure 4.1: Corner breaks

The corner breaks of the pavement mainly classified in three stations each corner breaks appeared on one slab bay expansion joint as shown in figure 4.1, the damage extent varies between 3m to 4m in length and has an average width between 10cm to 15cm as explained in a table 4.1. It contents; station, number of broken slab, damage extent in length and average width.

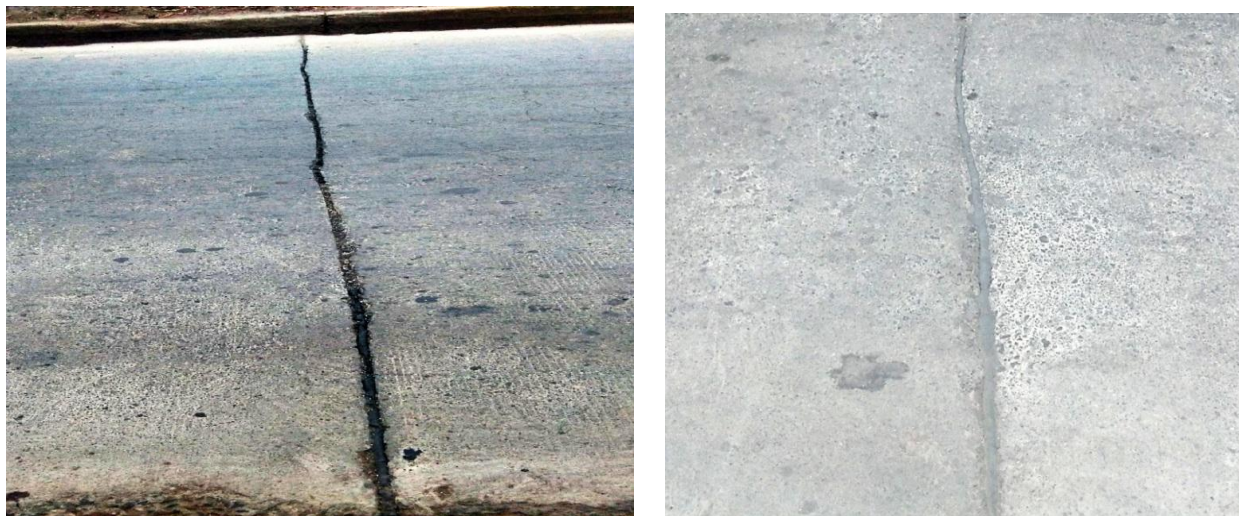
Figure 4.2: Joint seal damage

The road has transversal wearied out a sealing groove expansion joints and construction joints as shown figure 4.2. Transverse expansion joint and construction joint are types of joint exist on a pavement. From those recorded 10 levels of transverse joints in table 4.2 the 5 are fully damaged of covered seal and the others are more than 50% sealed coverage are damaged.

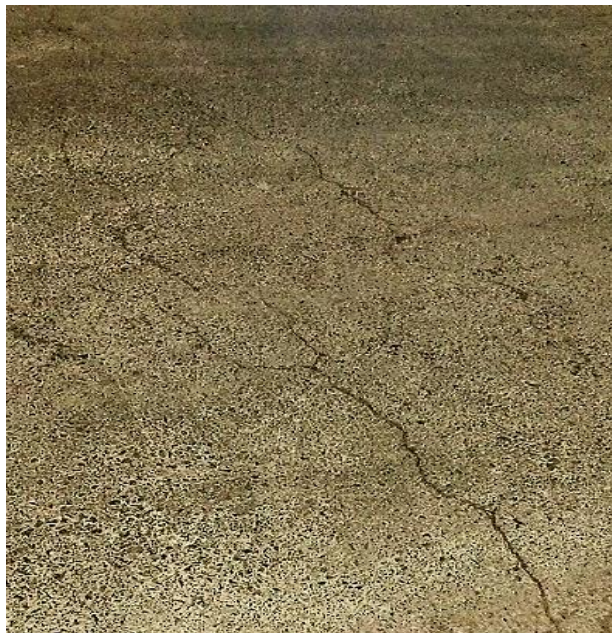
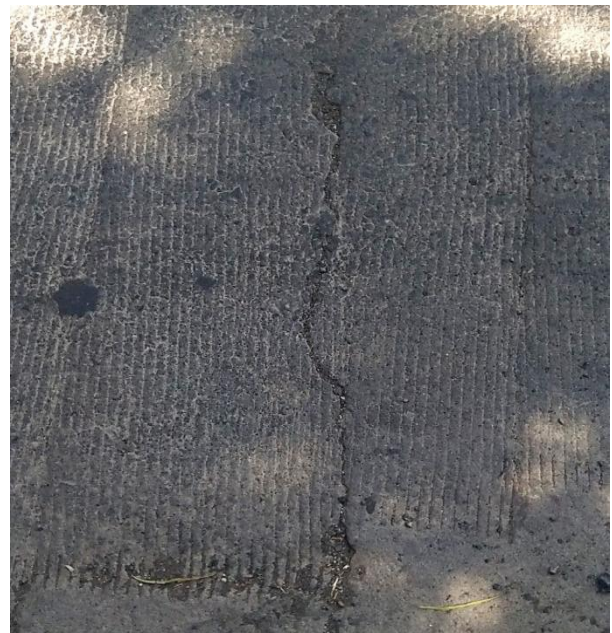
Figure 4.3: Surface cracking

Hence, depending on the observed distress pattern as shown in figure 4.3 below the cracks are classified as follow:

- Transverse cracking in a direction perpendicular to the center line covers extensively on the pavement has an average length 5.6m and width of 5.1mm.
- Longitudinal cracking in a direction parallel to the center line covers an average length 1m and width of 4mm.
- Alligator cracking in a pattern chicken wire structure covers an average length 0.35m and width of 4.5mm.

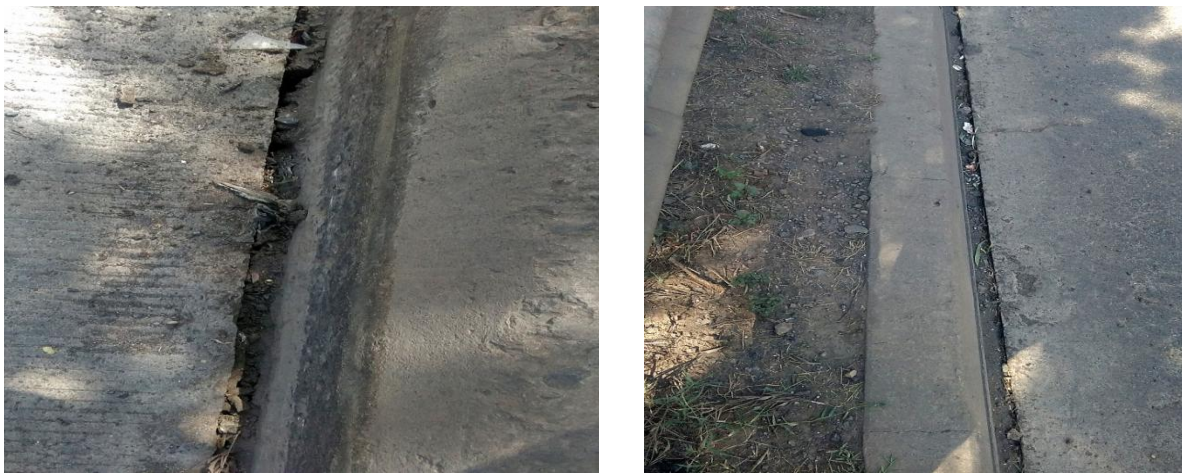
Figure 4.4: Lane-to-shoulder separation

Lane-to-shoulder separation indicate the space between lane and shoulder. As observed figure 4.4 proper expansion joint sealers don't provided and the extent of separation is recorded in average length 44.5m and width 26.6mm as shown in table 4.4.

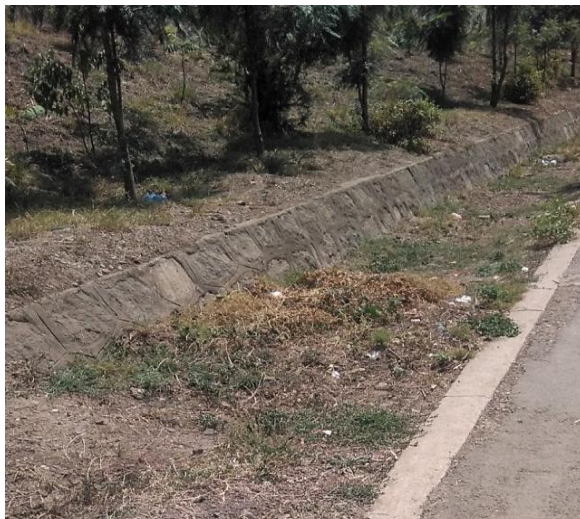
From topography view of the area the drainage system is not properly functional, the ditch blocked and covered by debris and eroded soil. As a result of this water will force to overflow on the pavement and infiltrate beneath of pavement structure. As shown from figure 4.5 the cross section and grading of the ditch cannot be easily collect surface runoff and safely drain out.

a) Ditch covered by eroded soil

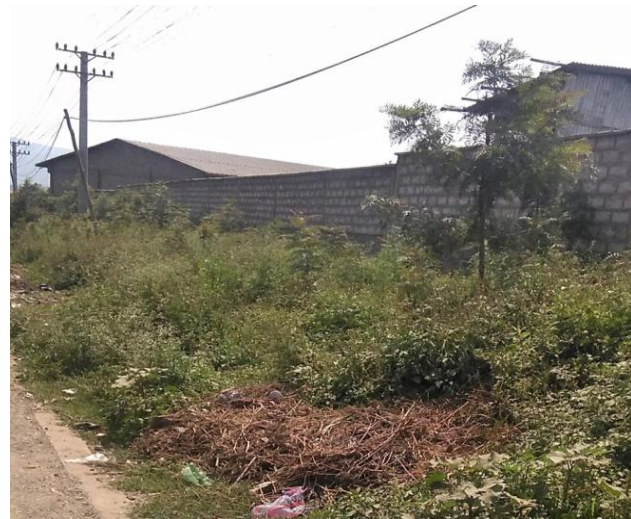
b) Ditch covered by plants
